# National Transportation Safety Board Aviation Accident Final Report

<b>Location:</b>	Presque Isle, Maine	<b>Accident Number:</b>	DCA19FA089
<b>Date &amp; Time:</b>	March 4, 2019, 11:29 Local	<b>Registration:</b>	N14171
<b>Aircraft:</b>	Embraer EMB145	<b>Aircraft Damage:</b>	Substantial
<b>Defining Event:</b>	Wrong surface or wrong airport	<b>Injuries:</b>	3 Minor, 28 None
<b>Flight Conducted Under:</b>	Part 121: Air carrier - Scheduled

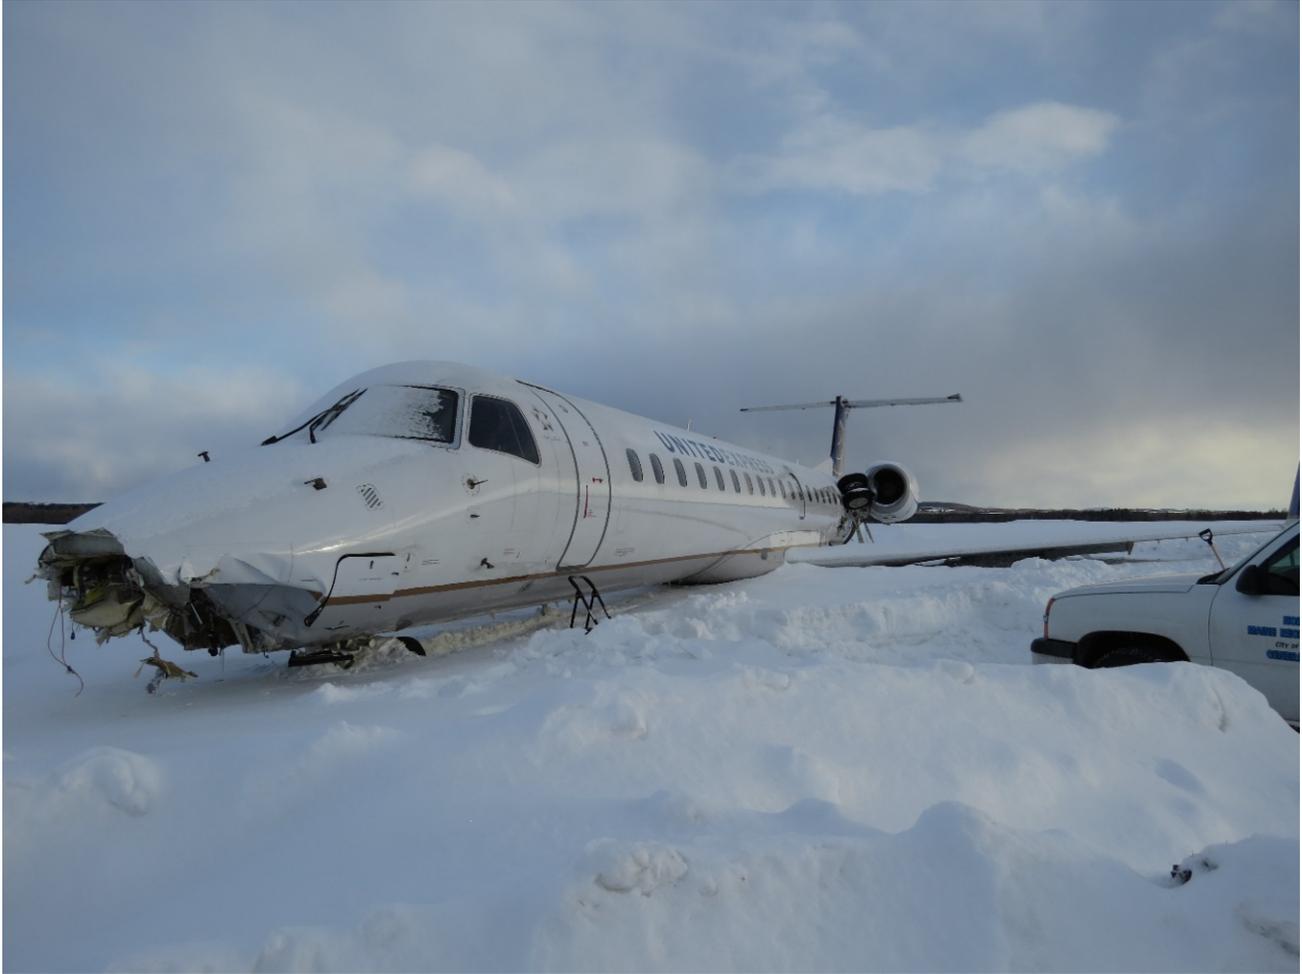
After the main cabin door was opened, the flight attendant noticed that the snow reached the bottom of the belly of the airplane. Firefighters came aboard the airplane; one attended to the first officer, who was injured, and one walked through the cabin to check on passengers. A snow plow created a walkway so that the crewmembers and passengers would not have to walk through the snow after exiting the airplane.

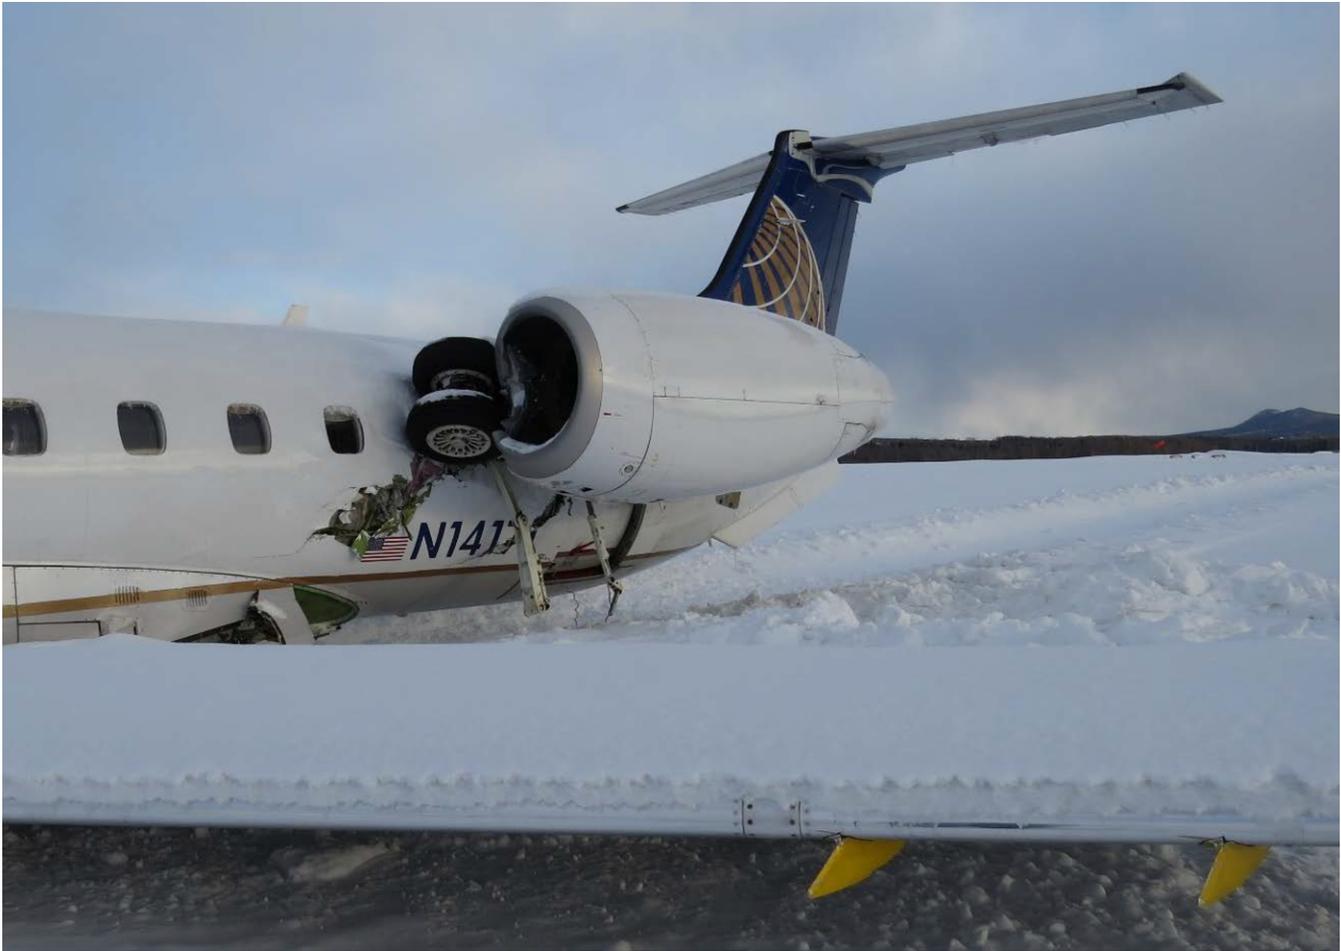
The left main gear was lodged between the left engine nacelle and fuselage. The fuselage structure in the area of the gear was ripped and damaged, and the fuselage around the gear wheels was distorted. The landing gear trunnion had penetrated the left engine gear box.

Figure 2: Left main landing gear lodged between left engine nacelle and the aircraft fuselage
