National Transportation Safety Board Aviation Accident Preliminary Report

Location:	Miami, FL	Accident Number:	DCA22FA132
Date & Time:	June 21, 2022, 21:38 UTC	Registration:	HI-1064
Aircraft:	McDonnell Douglas MD80	Injuries:	4 Minor, 136 None
Flight Conducted Under:	Part 129: Foreign

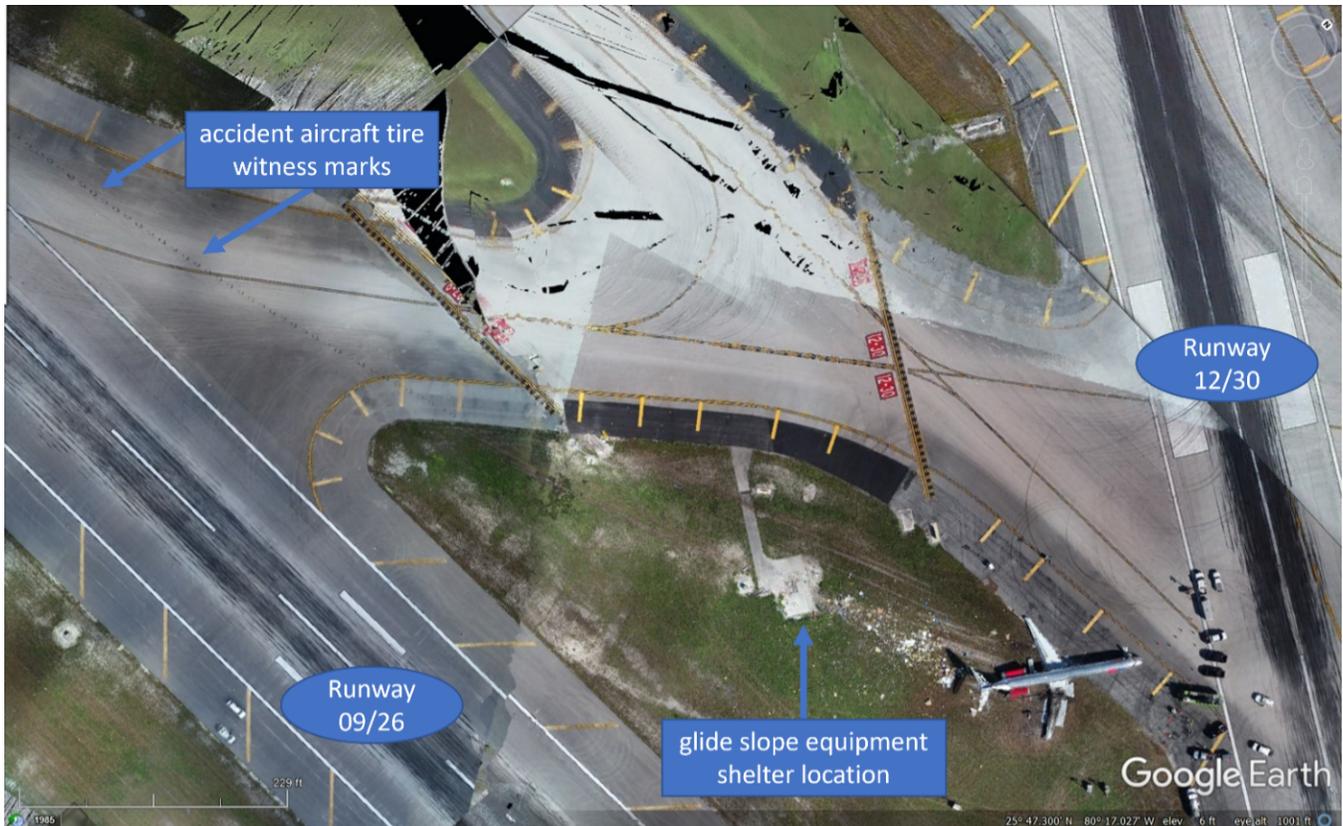
On June 21, 2022, about 1738 local time, RED Air flight 203, a Boeing MD-82, HI-1064, experienced a left main landing gear failure shortly after landing on runway 09 at Miami International Airport (MIA), Miami, Florida. The airplane departed runway 09 and came to a stop in the grassy area between runway 09 and 30. A post-crash fire occurred and was extinguished by Miami-Dade fire rescue (MDFR). The airplane was evacuated, and 4 passengers received minor injuries. The flight was a 14 *Code of Federal Regulations* Part 129 scheduled international passenger flight from Santa Domingo, Dominican Republic (SDQ) to MIA.

Figure 1. NTSB unmanned aircraft system (UAS) aerial image of aircraft wreckage and accident location taken June 23, 2022.

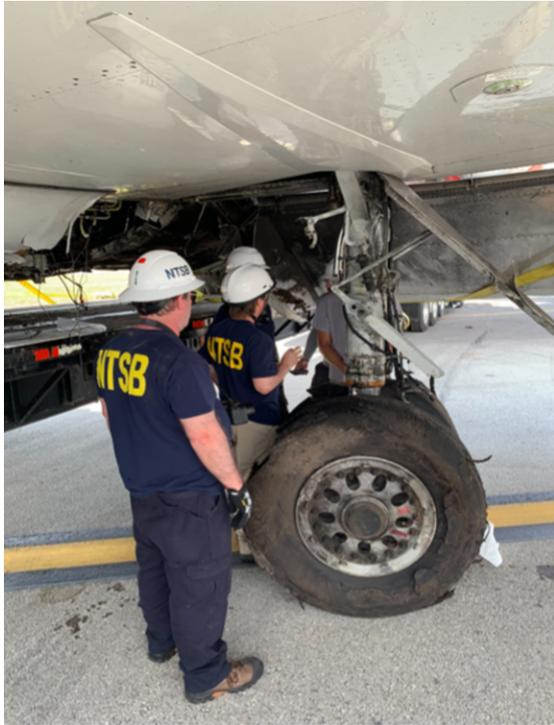
Figure 2. NTSB investigators inspecting the left main landing gear.

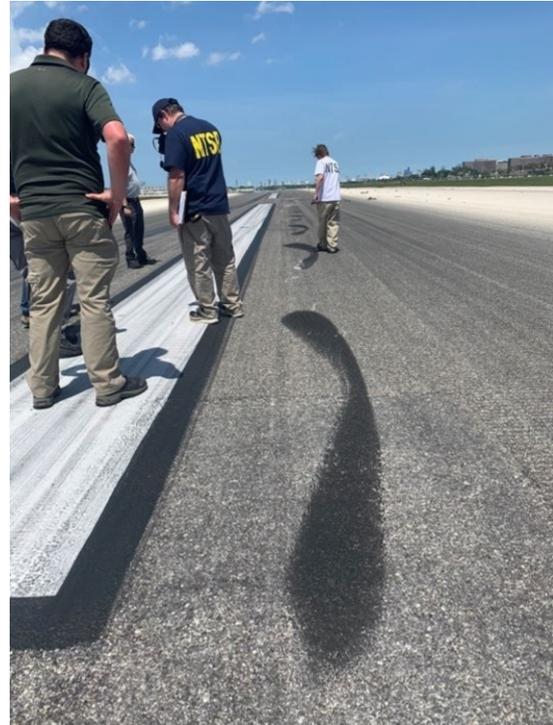
Figure 3. Investigators inspecting tire witness marks on runway 09.

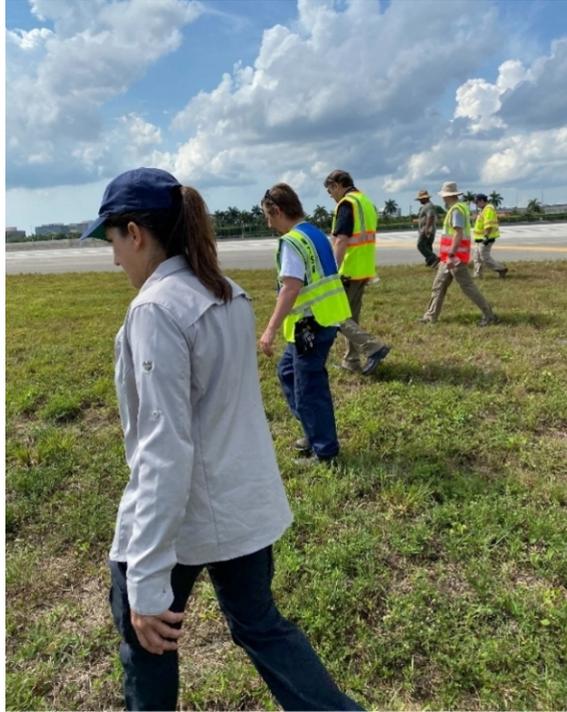
Figure 4. Investigators conducting a search for debris adjacent to runway 09.
