# Aviation Investigation Final Report

<b>Location:</b>	Boston, Massachusetts	<b>Incident Number:</b>	DCA23LA192
<b>Date &amp; Time:</b>	February 27, 2023, 18:54 Local	<b>Registration:</b>	N280LJ (A1); N179JB (A2)
<b>Aircraft:</b>	LEARJET INC 60 (A1); Embraer ERJ 190-100 IGW (A2)	<b>Aircraft Damage:</b>	None (A1); None (A2)
<b>Defining Event:</b>	Air traffic event	<b>Injuries:</b>	N/A (A1); N/A (A2)
<b>Flight Conducted Under:</b>	Part 91: General aviation - Positioning (A1); Part 121: Air carrier - Scheduled (A2)

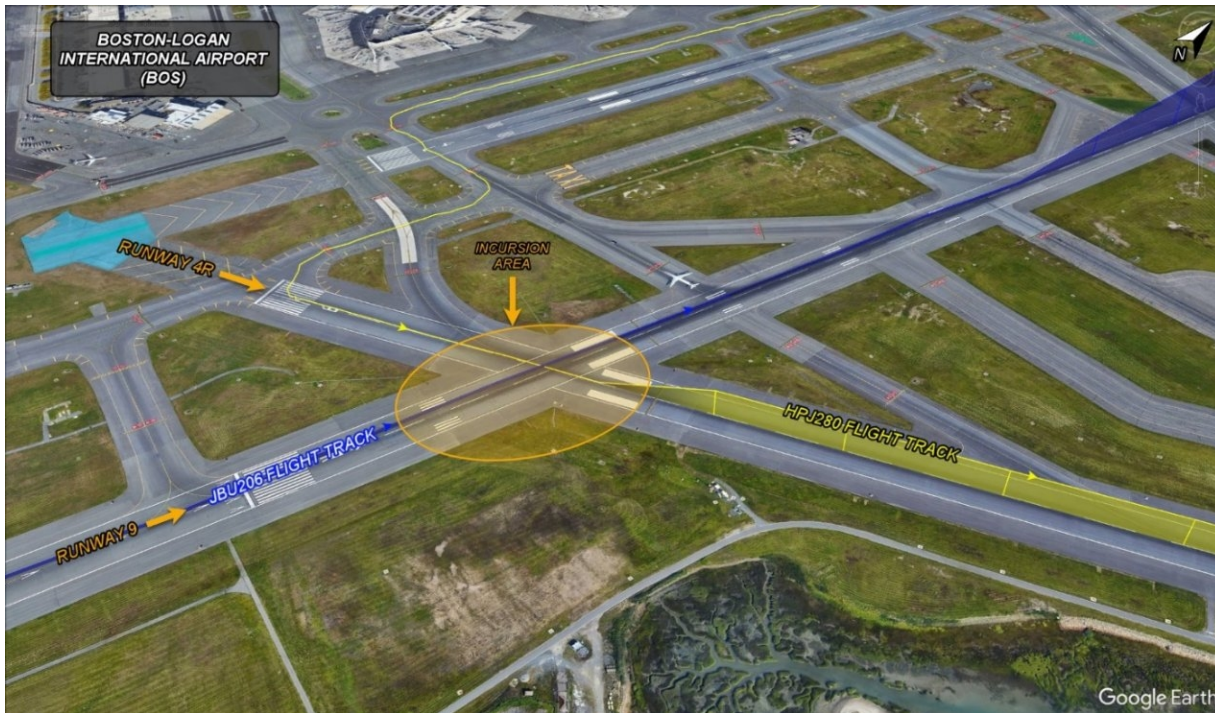
JBU206’s flight crew initiated a go-around while over runway 04R, prior to reaching the intersection with runway 09. The closest proximity between both airplanes occurred when JBU206 was about 30ft AGL during the landing flare, close to the point where both runways intersected, see figure 1. A video file taken by the occupant of the flight deck observer seat was provided to the NTSB and a screen capture from the video is shown in figure 2.

Figure 1. Flight tracks of both JetBlue (JBU206) and Hop-a-Jet (HPJ280) with yellow circle indicating incursion area.

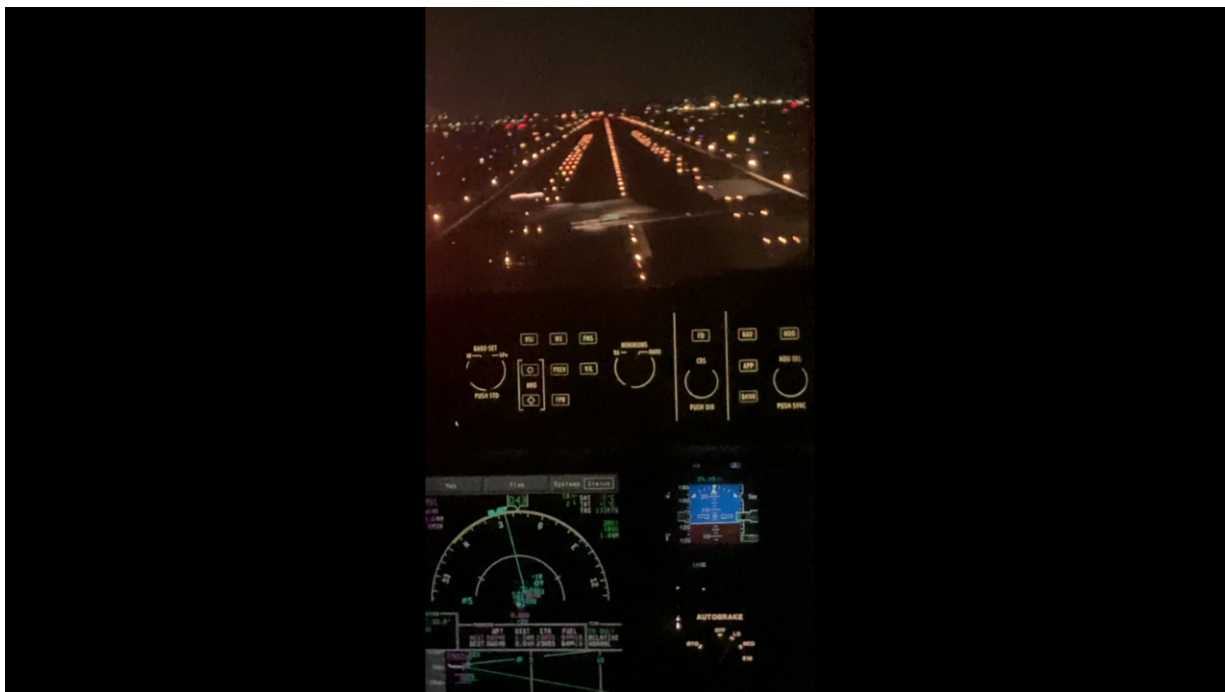
Figure 2: Screen capture from jump-seat occupant's video recording showing Lear 60 crossing runway centerline.
