Aviation Investigation Preliminary Report

Location:	Miami, FL	Incident Number:	DCA24LA079
Date & Time:	January 18, 2024, 22:34 Local	Registration:	N859GT
Aircraft:	Boeing 747-87UF	Injuries:	5 None
Flight Conducted Under:	Part 121: Air carrier - Non-scheduled

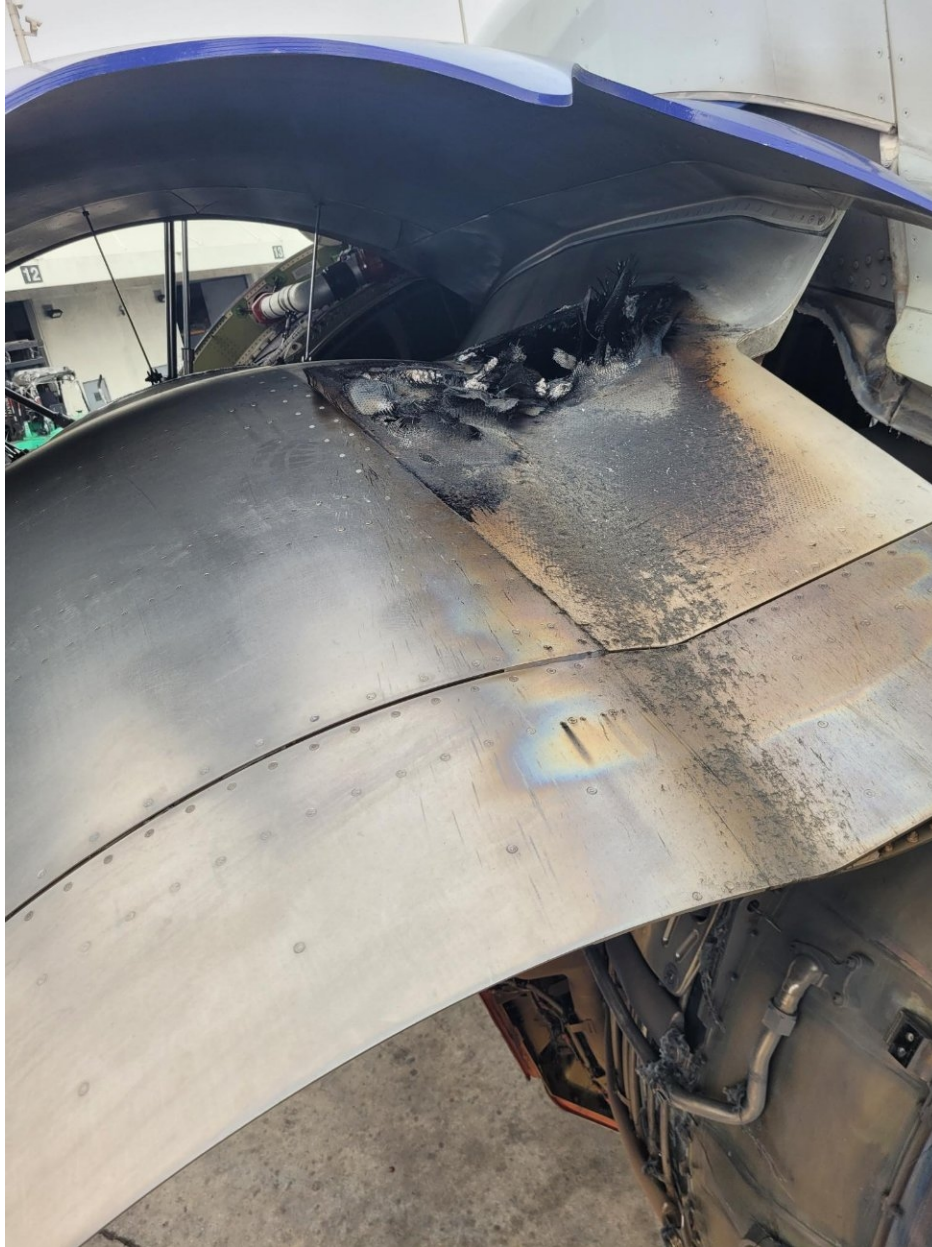
A post-incident inspection of the General Electric (GE) GEnx-2B67 engine revealed burn through of the thrust reverser fan duct fixed inner wall (see figure 1). The engine cases were intact and there was no evidence of an uncontained engine failure. The combustor diffuser nozzle (CDN) case port M borescope plug was not secured in the case and was found loose in the engine cowling. The burn through observed on the thrust reverser wall was directly above the open CDN port M. The engine low pressure spool (N1) and high pressure spool (N2) manually rotated smoothly. A borescope inspection through CDN port M was performed and no combustor damage was visible. A preliminary review of quick access recorder (QAR), flight data recorder (FDR), and continuous engine operating data (CEOD) showed no evidence of engine failure or surge/stall.

Figure 1 - Burned area above borescope port M. (Source: Atlas Air.)

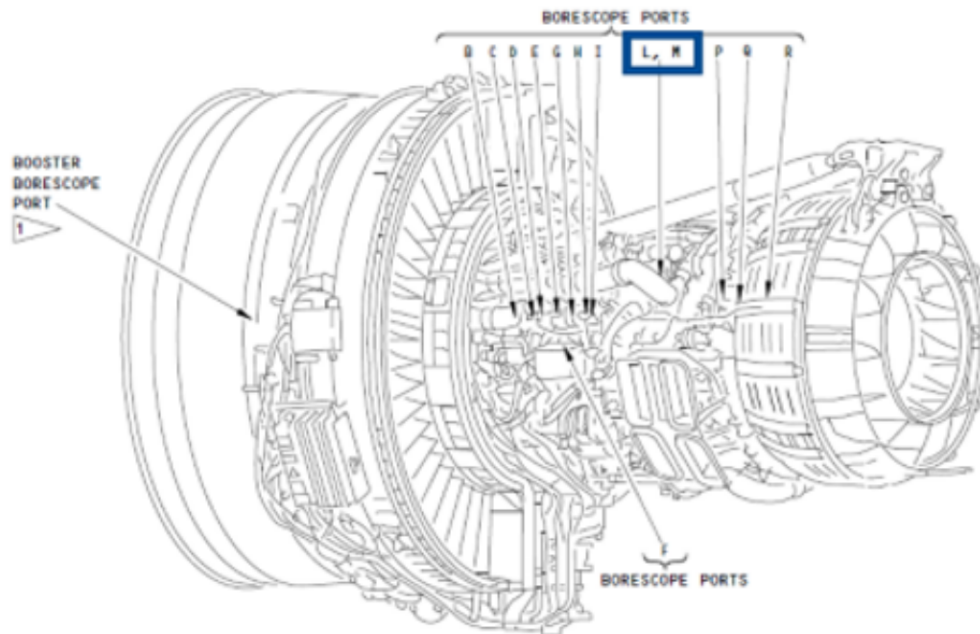
A review of the aircraft's maintenance records revealed that on January 14, 2024, the aircraft underwent an "ENG 2 COMBUSTION SECTION- BORESCOPE NOZZLE- INSPECT" performed by a third-party vendor that required the removal of the port M borescope plug (see figure 2 for location of port M). The maintenance work card provided instructions on how to properly reinstall the borescope plugs to ensure the locking feature was properly engaged. The work card was initialed by the technician performing the work and an inspector, indicating this task had been completed in accordance with the maintenance manual procedure.

Figure 2 - Engine diagram with Port M depicted in the combustor diffuser nozzle. (Source: General Electric.)
