# Aviation Investigation Preliminary Report

| <b>Location:</b> | Philadelphia, PA | <b>Accident Number:</b> | ERA25MA106 |
| <b>Date &amp; Time:</b> | January 31, 2025, 18:07 Local | <b>Registration:</b> | XA-UCI |
| <b>Aircraft:</b> | Learjet 55 | <b>Injuries:</b> | 7 Fatal, 4 Serious, 20 Minor |

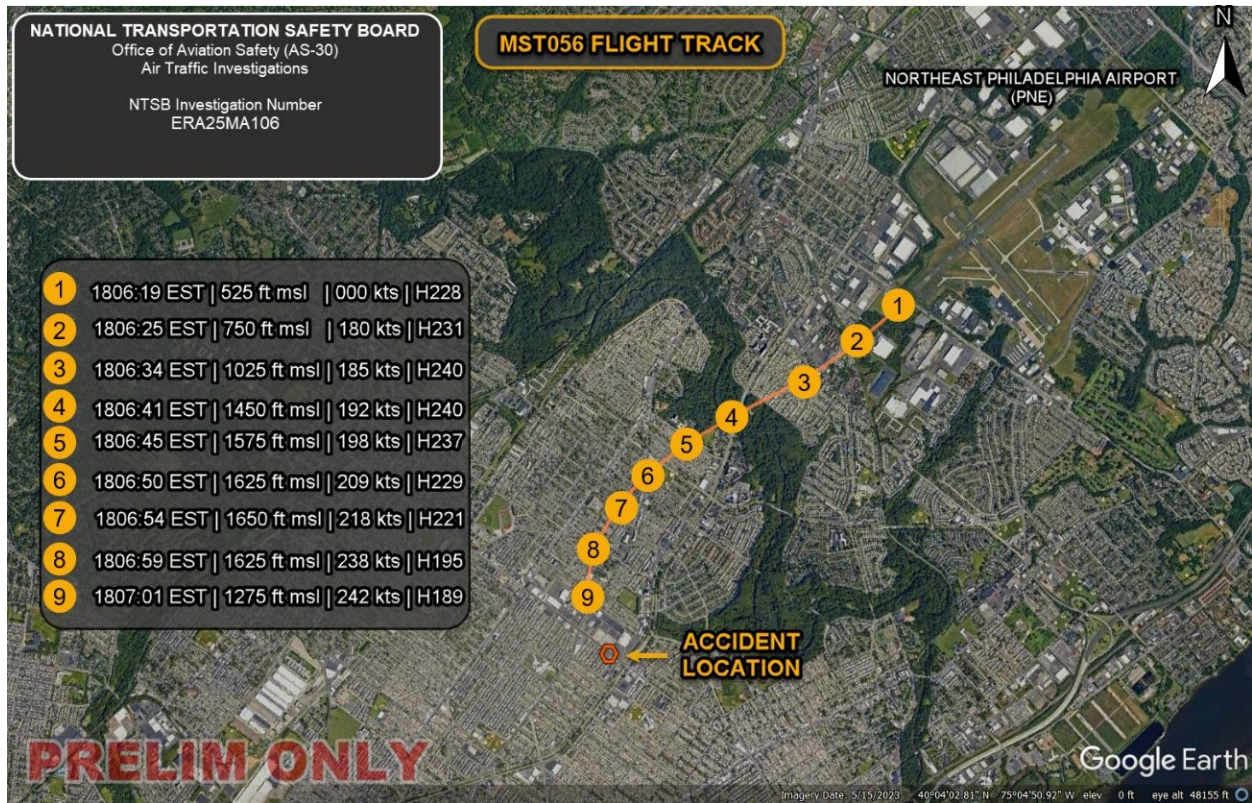
Preliminary ADS-B flight track data obtained from the Federal Aviation Administration revealed that the flight departed runway 24 at Northeast Philadelphia Airport (PNE), Philadelphia, Pennsylvania, about 1806, with the intended destination of Springfield-Branson National Airport (SGF), Springfield, Missouri. The airplane proceeded to the southwest before it turned right slightly and then entered a gradual left turn. The airplane continued in the left turn and reached an altitude of 1,650 ft mean sea level (airport elevation was 119 ft). The track data ended at 1807, at 1,275 ft msl, and at 242 knots ground speed. The duration of the flight was about 1 minute (see Figure 1).

Figure 1. Aerial image with the airplane's ADS-B flight track and the accident location overlaid.
