Technical report

IN-001/2024

Incident occurred on 17 February 2024 to
aircraft Airbus A321, registration D-AISO, in
Madrid (Spain)

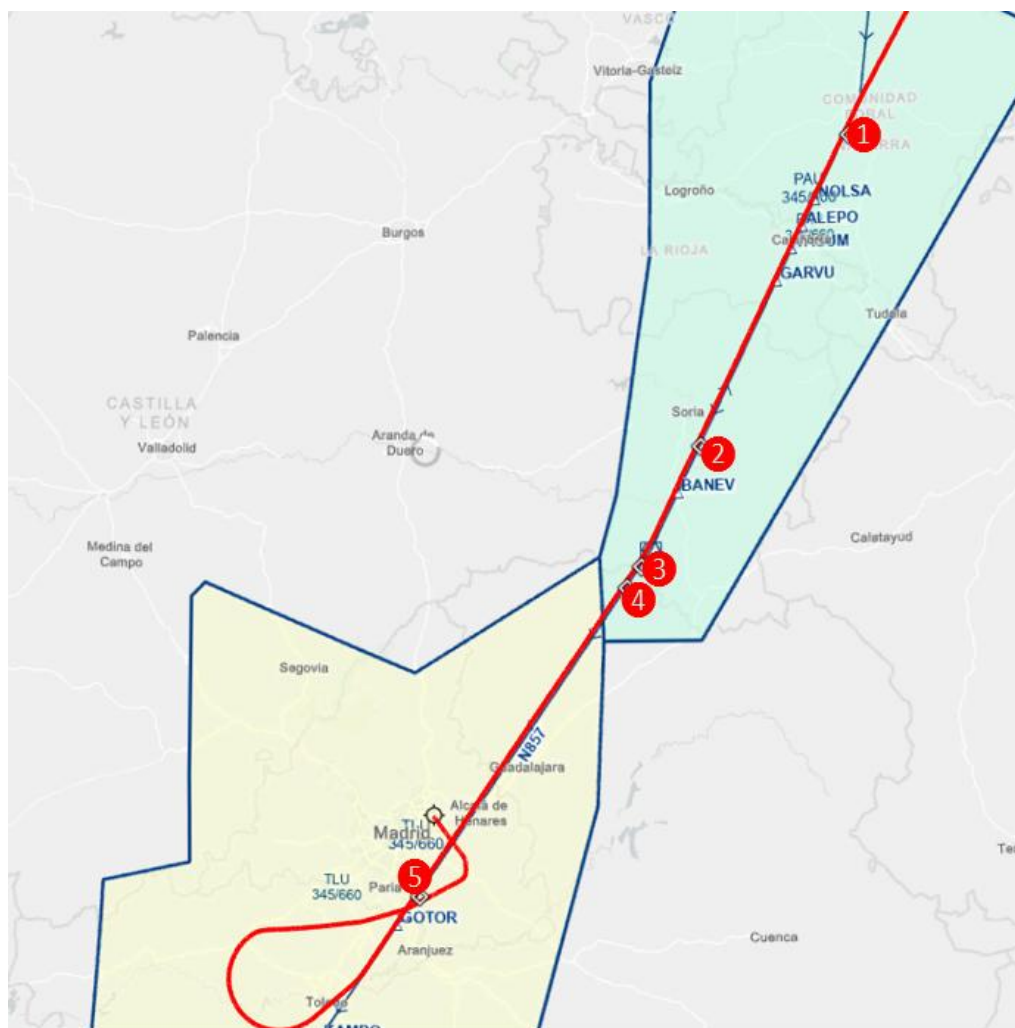
Figure 3: Flight path of the aircraft in the PAU (green) and TLU (yellow) sectors

Subsequently, at 10:34:51 UTC (see ③ in Figure 3), when the co-pilot was alone on the flight deck, the controller made three attempts to contact the crew to transfer control of the aircraft to the next en-route sector, the TLU. There was no response from the co-pilot as he was incapacitated.

At 10:35:31 UTC (see ④ in Figure 3), the controller of the PAU sector contacted the TLU sector, at the same time as another Lufthansa aircraft contacted the TLU sector. Upon hearing the callsign, the controller of the PAU sector assumed that it was the one involved in the incident (the controller of the TLU sector initially mistakenly addressed the other Lufthansa aircraft with the call sign LH77X).

The next communication with ATC occurred after the captain returned to the flight deck. He contacted the PAU sector controller at 10:43:51 UTC (see 5 in Figure 3) to ask to descend, explaining that they had a medical problem on board, and requested vectors to LEMD. The aircraft was transferred to the TLU sector frequency. Subsequently, it declared a medical emergency and requested the service of an ambulance. The air traffic controllers coordinated with the airport manager to facilitate medical assistance, assigning the aircraft to a parking stand near the runway and arranging for an ambulance to meet it on arrival.

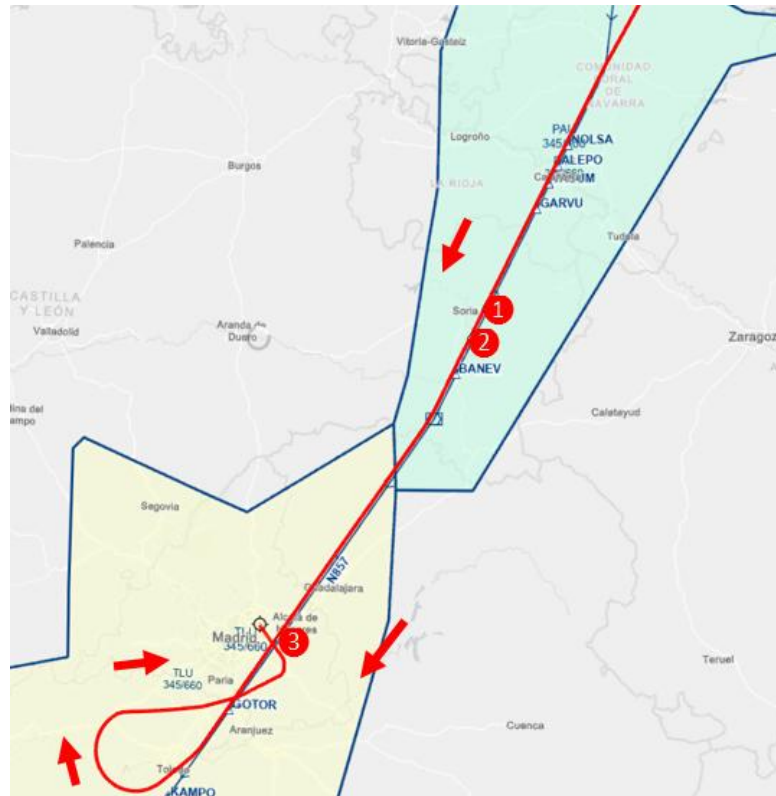
Figure 6: Flight path of the aircraft on the ENAIRE route map

Time in UTC	Event
①	10:31:30	The captain leaves the flight deck
②	10:32:06	Incapacitation of the co-pilot begins
③	10:42:04	The captain enters the flight deck
